# Blade Pitch Angle Inspection Report

**WTG: EX-XXX**

**Parc éolien d'XXXXXX,  
(Ardennes, France)**

**Measurement date : 10/04/2017**

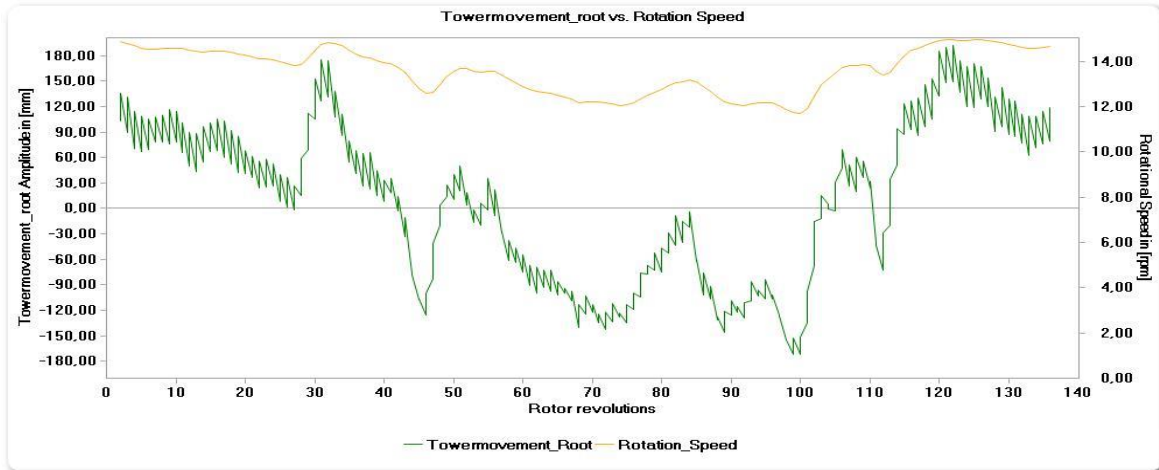
Towermovement\_root vs. Rotation Speed

**Correction recommended:** The pitch difference of 1,25° is higher than the 0,6° recommended by GL\*. The tower oscillation graph presents some abnormal high frequency oscillations (50mm amplitude) compared to the same wind turbine with correct pitch angle.

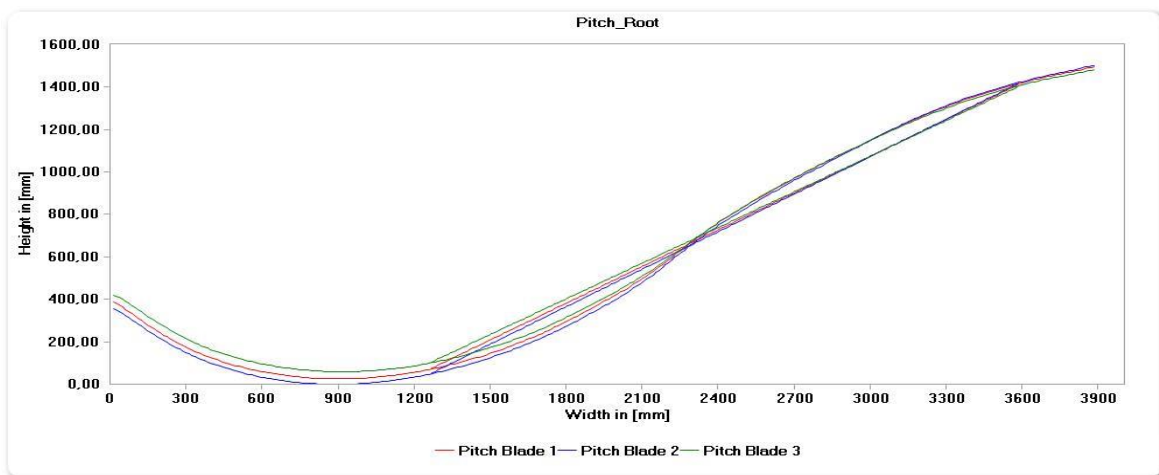
Pitch\_Root

Initial	Blade 1	Blade 2	Blade 3	Difference
Root[°]	0,07	0,59	-0,66	1,25
Tip[°]	0,15	0,66	-0,81	1,47
Twist[°]	0,08	0,07	-0,15	
Half Twist[°]	0,08	0,05	-0,10	0,18
Sharing(°)	0,09	-0,26	0,18
