# Blade Pitch Angle Inspection Report

**WTG: EX-XXX**

**Parc éolien d'XXXXXX,  
(Ardennes, France)**

**Measurement date : 10/04/2017**

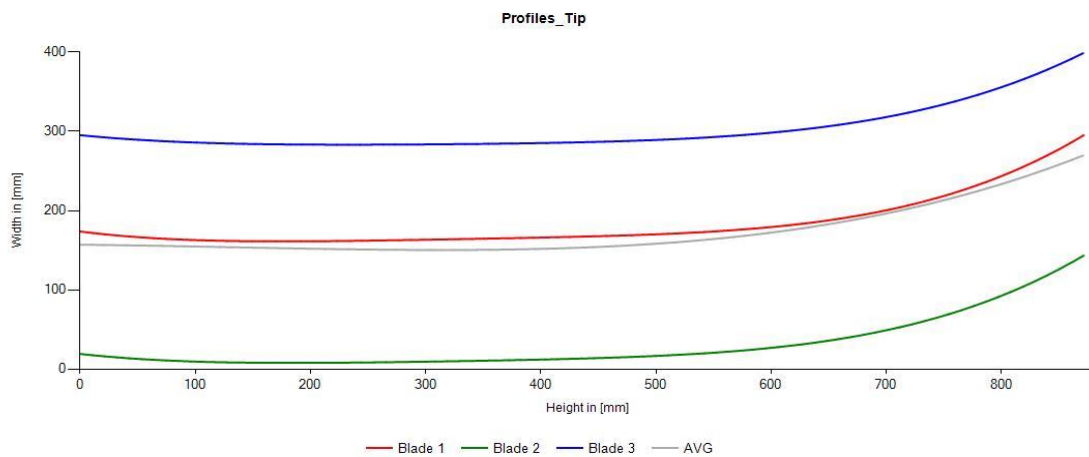
Profiles\_Tip

Initial	Blade 1	Blade 2	Blade 3	Difference
Root[°]	0,07	0,59	-0,66	1,25
Tip[°]	0,15	0,66	-0,81	1,47
Twist[°]	0,08	0,07	-0,15	
Half Twist[°]	0,08	0,05	-0,10	0,18
Sharing(°)	0,09	-0,26	0,18

**Correction recommended:** The pitch difference of 1,25° is higher than the 0,6° recommended by GL\*. The tower oscillation graph presents some abnormal high frequency oscillations (50mm amplitude) compared to the same wind turbine with correct pitch angle.
