ROMEG REPORT USER GUIDE

Alpha **Wind** SAS

Example of result table

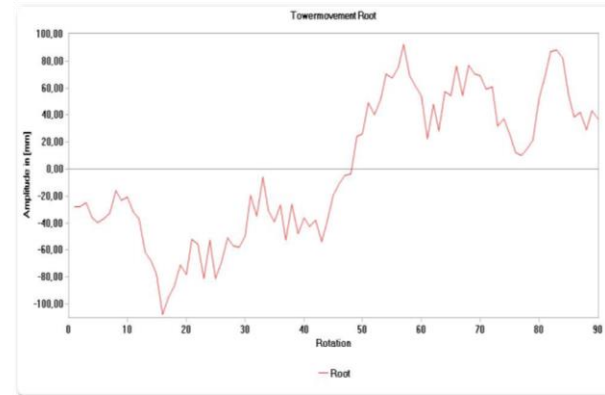
Tower vibration with 0.2° blade angle difference

In the graphs above, a high frequency vibration is visible with the 1,2° blade angle difference tower oscillation. The amplitude of the vibration is up to 60mm, while after adjustment, the high frequency is barely noticeable.

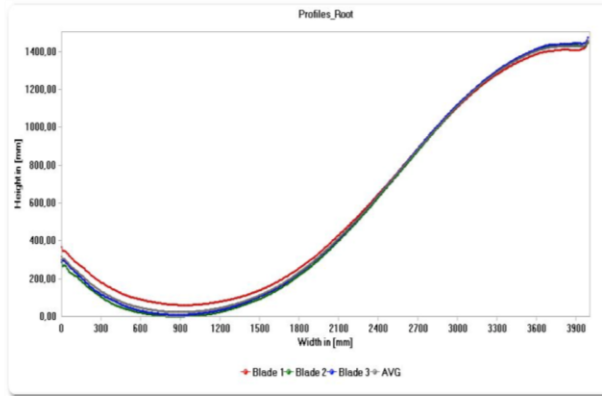
Blade angle difference of 1.2°

The blade angle difference is the most important result from the Romeg inspection. The 2 graphs above show the 3 blade profiles and the average one before and after correction.

We can see on the left graph that the blade 1 (in red) does not have the same pitch angle as the 2 others.

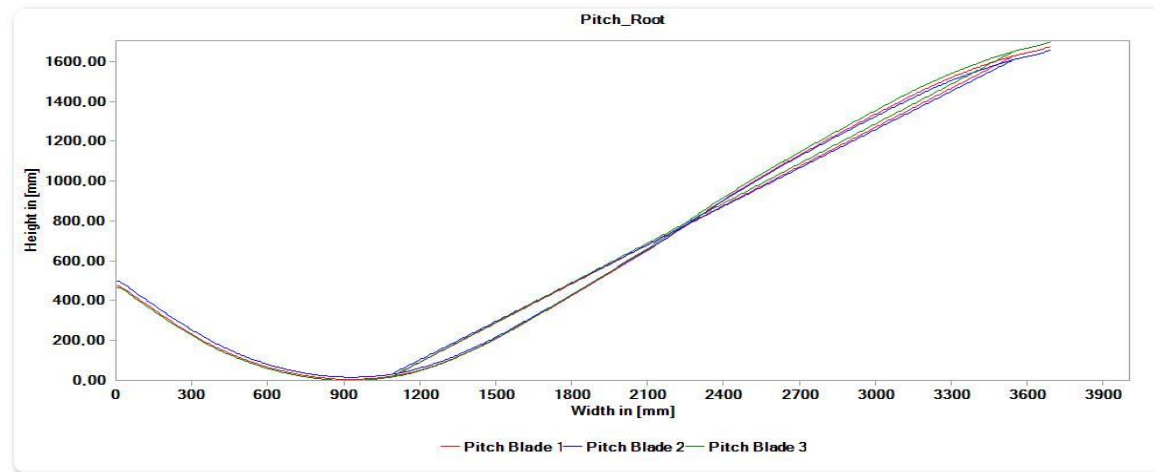
Pitch root graph with 0,9° blade angle difference

This graph is only for information, indicating how the blade angle of each blade is calculated.

The blade angle difference is usually well visible on this graph.
